# **ANNUAL ENVIRONMENTAL AUDITING REPORT - SEPTEMBER 2023**

**EIA CERTIFICATE NO.EC/EIS/598**

**PREPARED BY: GAS COMPANY TANZANIA LIMITED - TPDC**

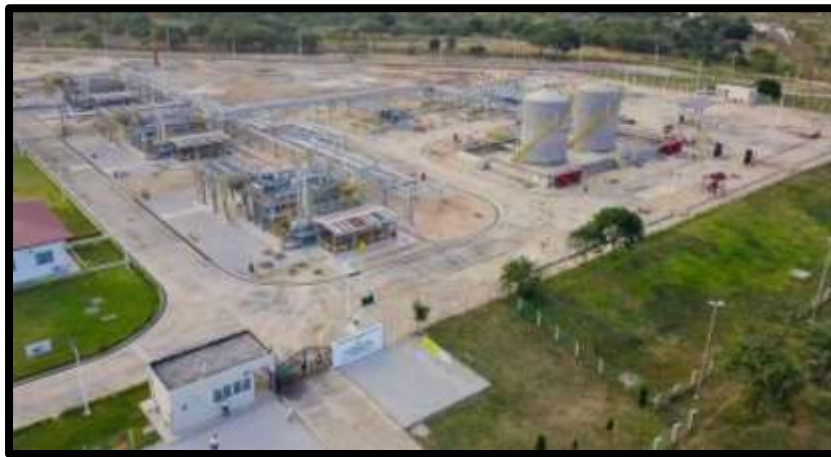
**Figure 1:** Processing plant

The area is categorized into two, processing area and staff camping site. Processing area have series of gas processing units which include gas reception, separation unit, condensate stabilization unit, Dehydration unit, power generation unit, waste water treatment, raw water treatment, gas flaring, gas export, compressor, nitrogen generation, warehouse, office building and control room.

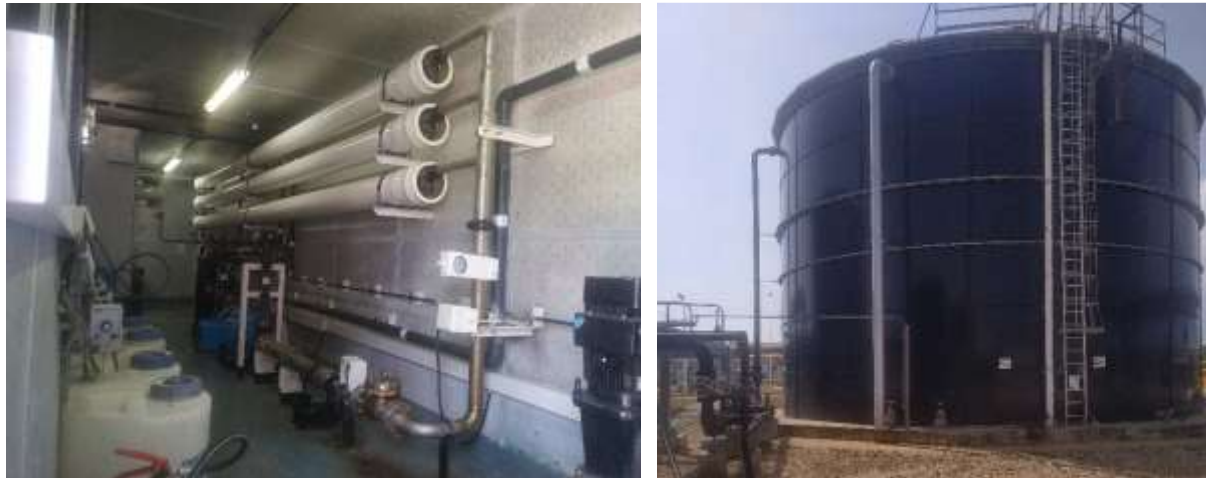
**Figure 4:** Reverse Osmosis unit for portable Water Treatment & Storage tank

m<sup>3</sup> per annum. The method used for treating water is reverse osmosis; a technology that is used to remove a large majority of contaminants from water by pushing the water under pressure through a semi-permeable membrane. It is capable of removing up to 99% + of the dissolved salts (ions), particles, colloids, organics, bacteria and pyrogens from the feed water. Figure 4 below shows the reverse osmosis unit and portable water storage tank. In addition, water storage tank capacity at each site is illustrated at the table 1.

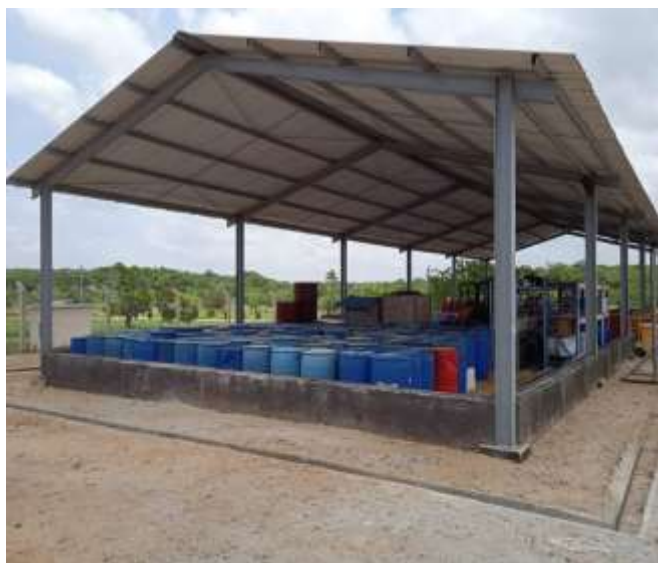
**Figure 6:** Chemical Storage Shed

- i. Chemicals are stored in the warehouse and a chemical shed area (figure 6)
- ii. Stocked spill kits (figure 7) are available at the spill and leak prone area (warehouse and generator room) for spill emergency purpose, these are inspected regularly and workers are trained on how to use.
- iii. Broken Chemical solvents containers/ Glasses are stored in a specified bin in the waste transfer station awaiting disposal figure 8.
- iv. SDS were observed to be placed in chemical storage area and laboratory. Workers are trained in handling and management of chemical through GCLA Southern Zone Laboratory

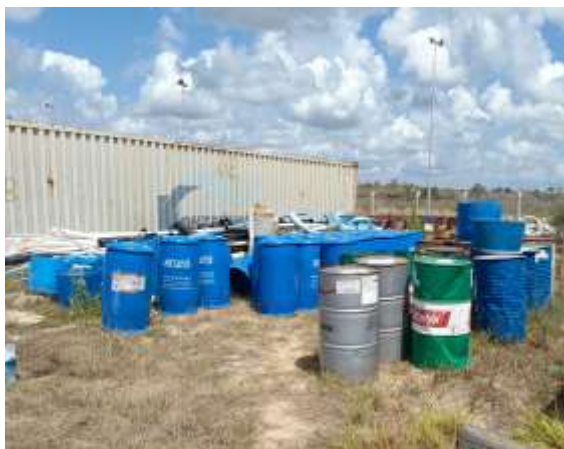
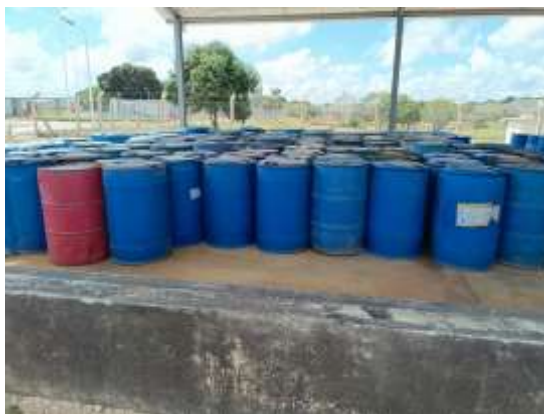
- i. Significant number of marked collection bins according to waste category on site at different waste generation location.
- ii. Non Hazardous Wastes disposal carried out by the service provider for site cleaning and are all required to be disposed in approved municipal dumping sites. For example, in Songosongo Island are stored in transfer station before being removed for disposal at Kilwa Masoko under the supervision of Kilwa Masoko District Environment Officer, Madimba all wastes are taken to Mtwara Landfill and at Kinyerezi station wastes are taken to Pugu Kinyamwezi. All evidence like municipal waste disposal receipt are kept filled.

- iii. The company contracted a licensed medical waste contractor TINDWA to manage all medical waste disposal
- iv. Pileup of scraps metals, waste oil and empty drums were observed at Madimba and Songosongo waiting for government approval to dispose them.

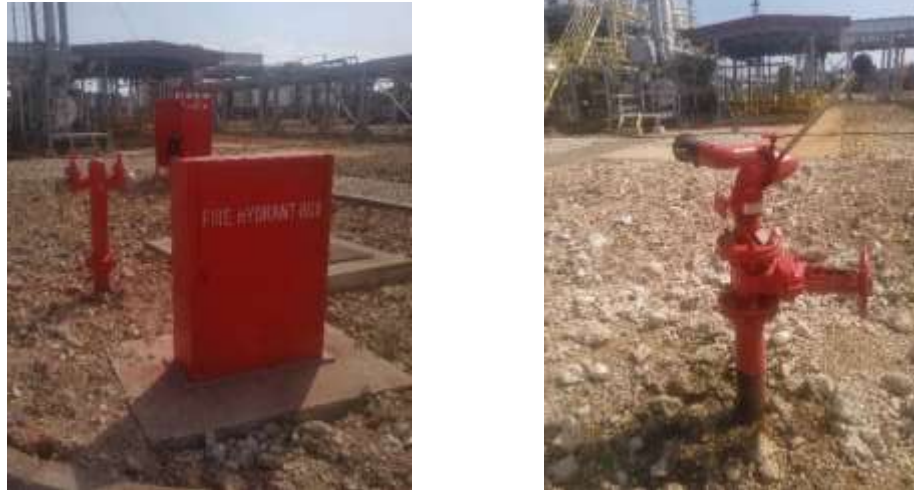
**Figure 9:** Fire hydrant and fire monitors

- ii. The plant and receiving stations are equipped with state of the art Gas and flame detection systems, to identify leaks and naked flames
- iii. The present of fire extinguishers to be used in case of fire event; are equipped with information regarding date of next services, positioned at several parts of the processing plant, office building, workshop, warehouse and staff camping site. These are inspected every month (internally) and serviced on annually basis through a certified dealer.
